# Restoration and Disaster-Resilient Rehabilitation of the University of Peradeniya Following the Ditwah Cyclone Floods

## 1. Background and Situation Analysis

## 2. Extent of Damage to University Infrastructure

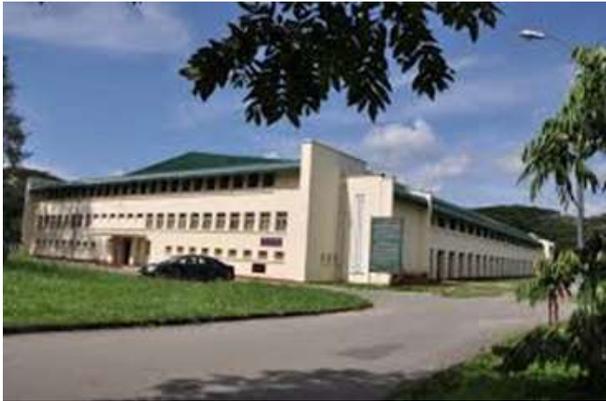
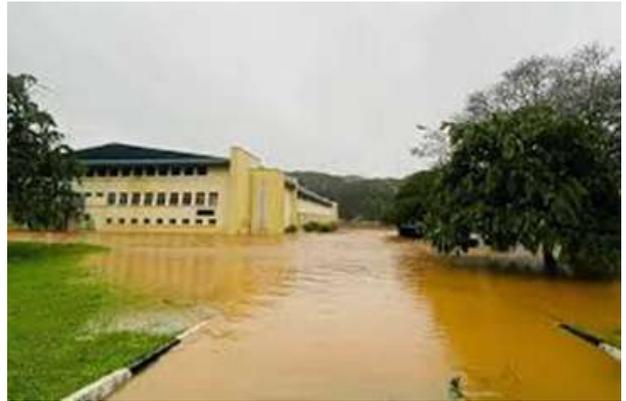
Figure 1: University of Peradeniya Gymnasium before and after the flooding

- Level of Damage: Partial
- Description of Damage: Wooden floor is warped (60x30m).
- Recovery Action: Attempt to recover through drying, cutting, and polishing with termiticide treatment; full replacement if recovery fails.
- **Recovery Cost (Rs. mn): Termiticide treatment (3), cutting and polishing (3), or Replacement (50)**

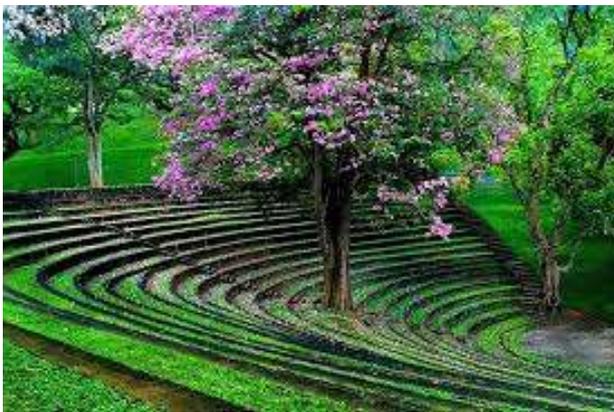
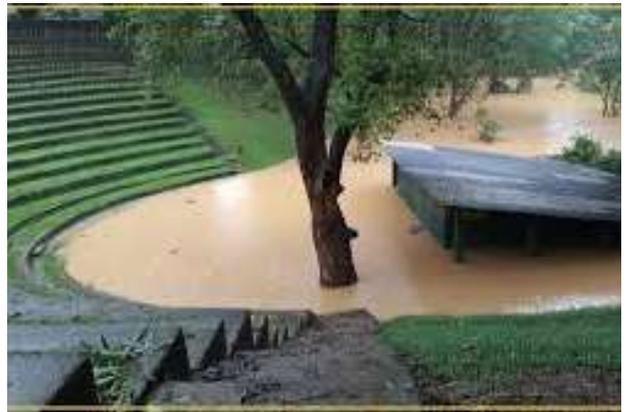
Figure 2. University of Peradeniya Prof. Ediriweera Sarachchandra Open Air Theatre before and after the flooding

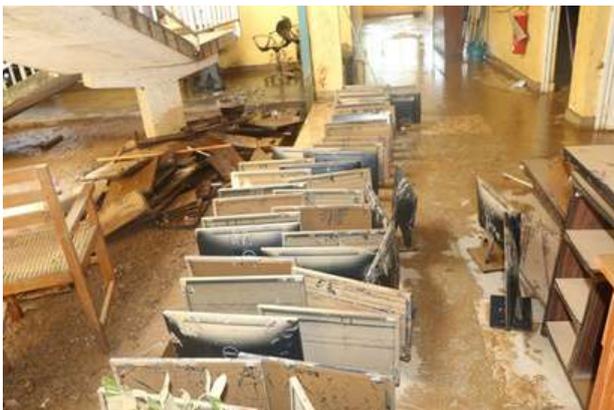
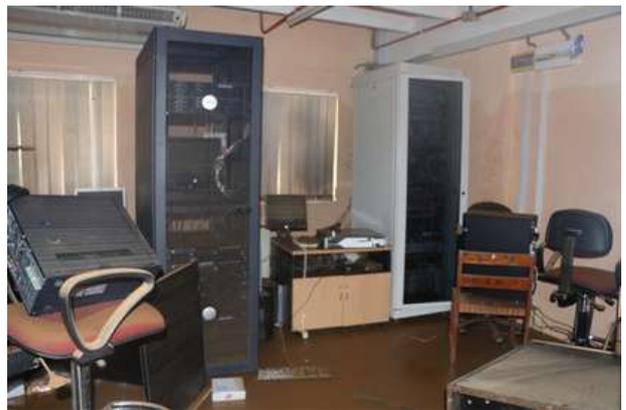
Figure 3. Flood damage in the IT Centre, University of Peradeniya

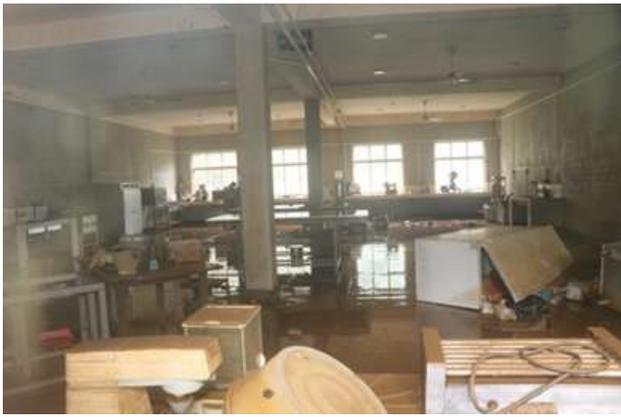
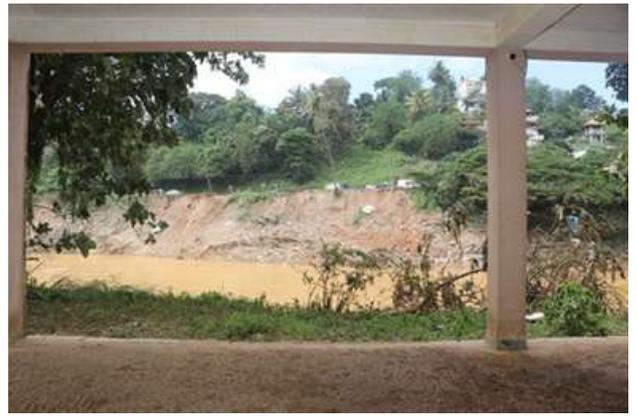
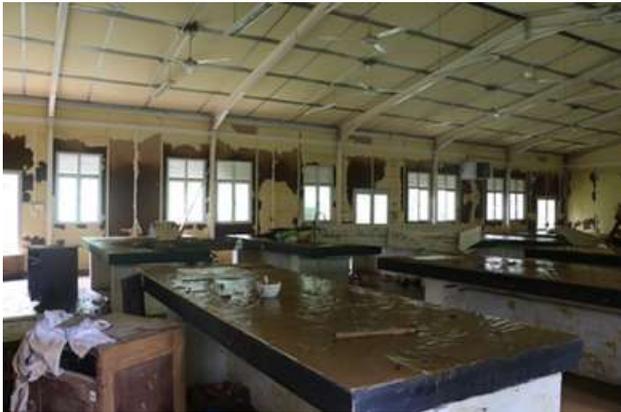
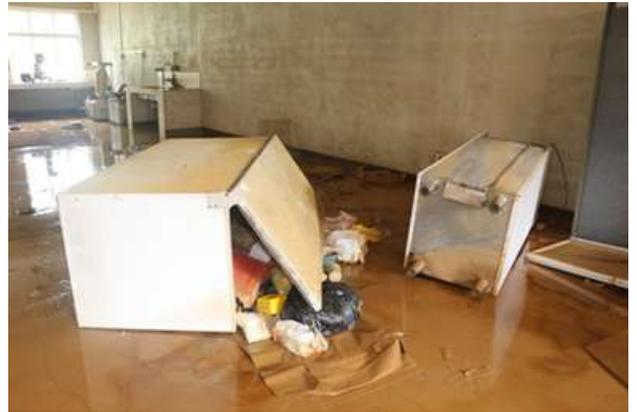
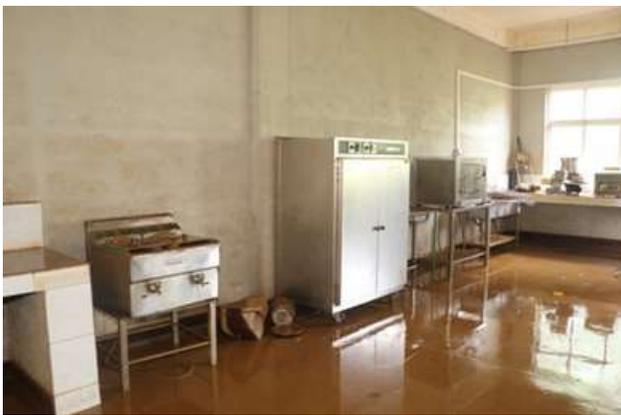
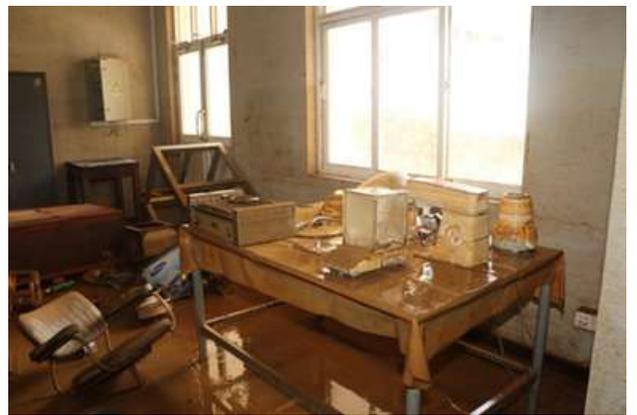
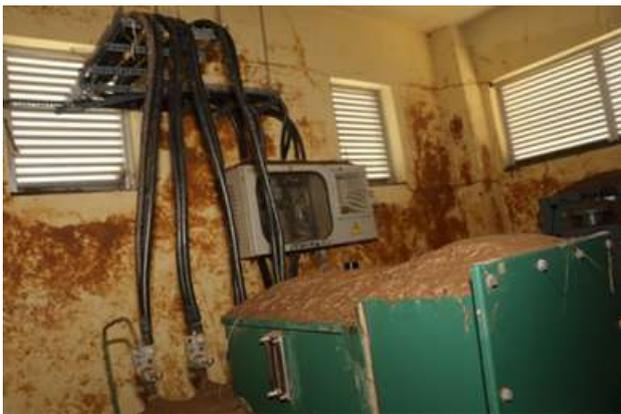
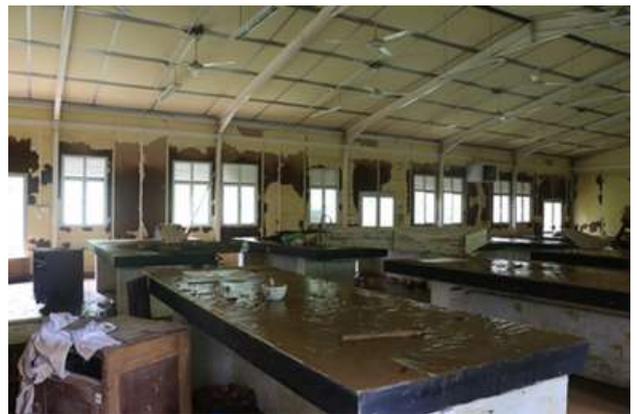
Figure 4. Flood damage to the Department of Animal Science, Faculty of Agriculture, University of Peradeniya

- The Department of Animal Science has sustained additional losses due to damage to the department building, vehicles, generator, elevator, and CCTV system
- **Approximate Recovery Cost: Rs. mn 15**

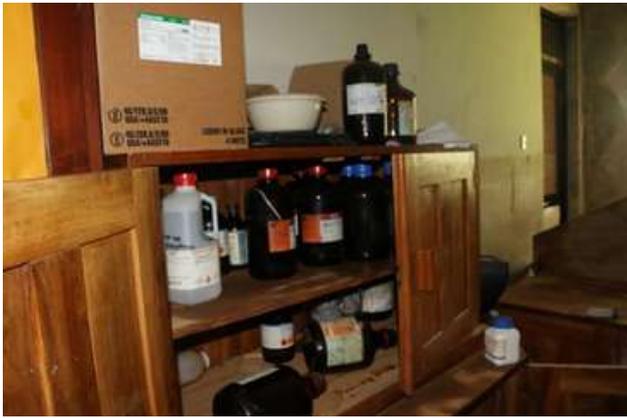
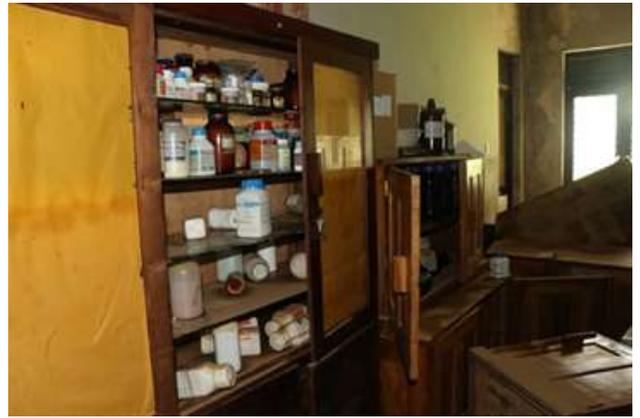
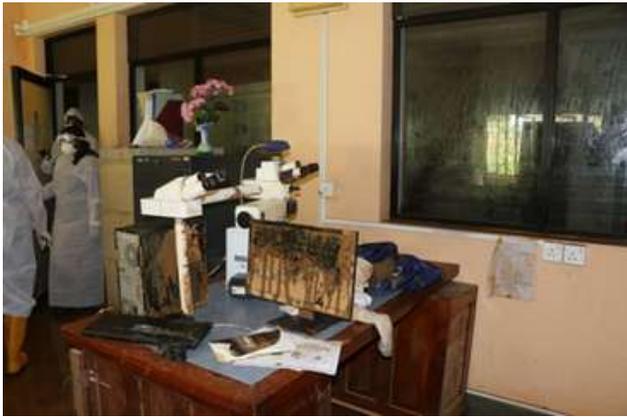
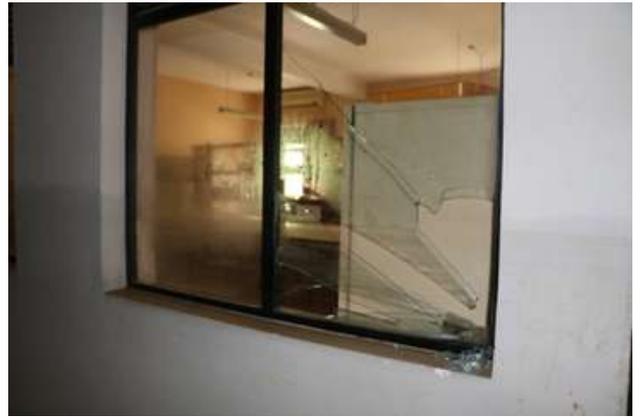
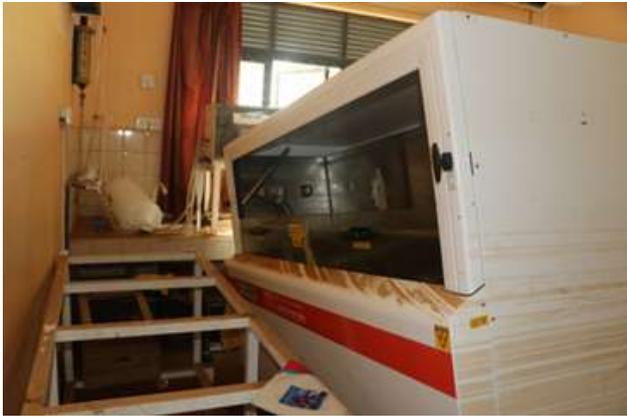
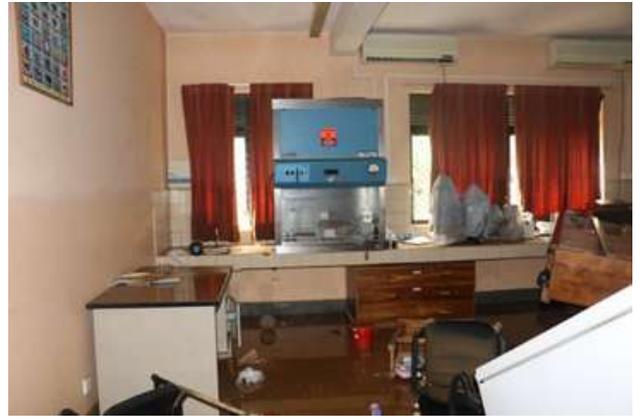
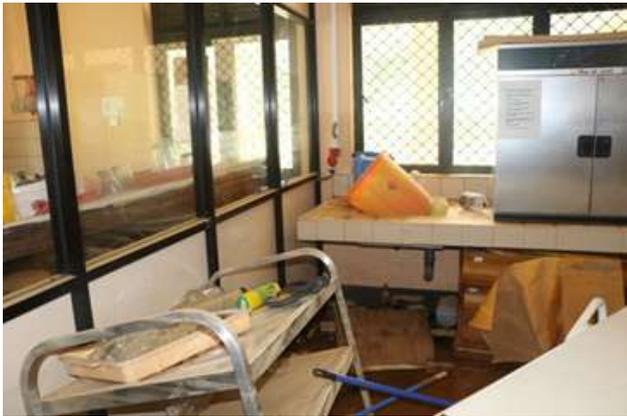
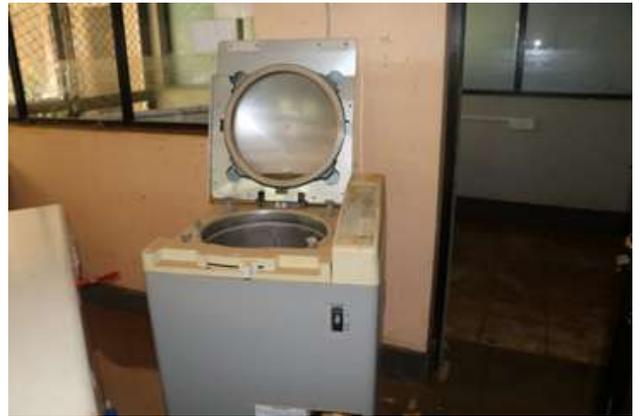
Figure 5. Flood damage to the Centre for Aquatic Animal Disease Diagnosis and Research (CAADDR), Faculty of Veterinary Medicine and Animal Science

- Restoration of class room teaching, practical training, clinical training, ongoing research, service functions, and administrative works at the CAADDR, MD-DVPB and PR-DVPB
- Sent for repair to the local agents
- Progress: 5%
- **Approximate Recovery Cost: Rs. mn 5**

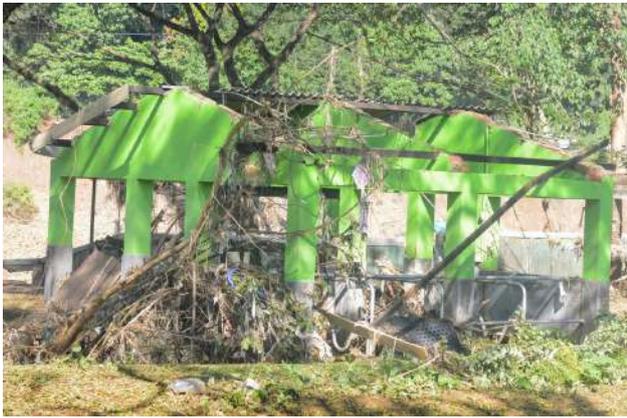
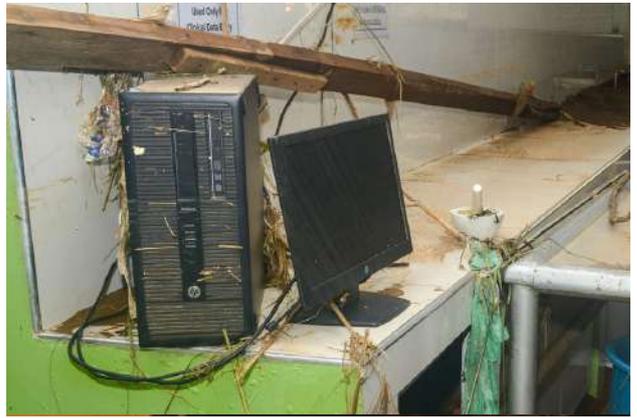
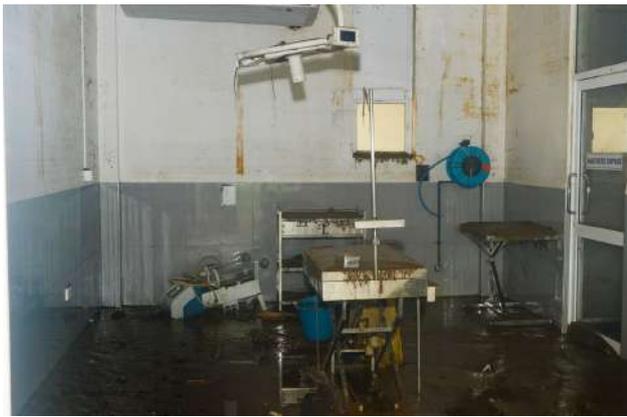
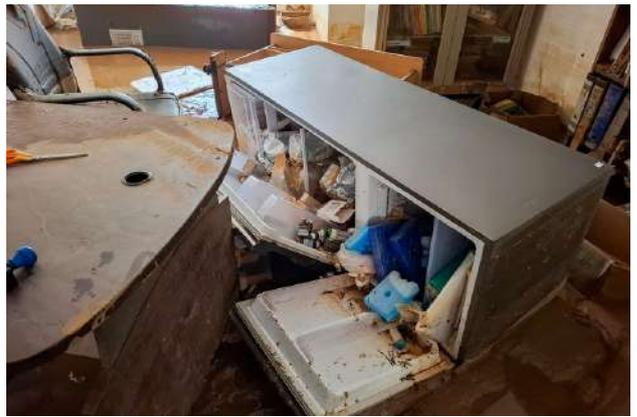
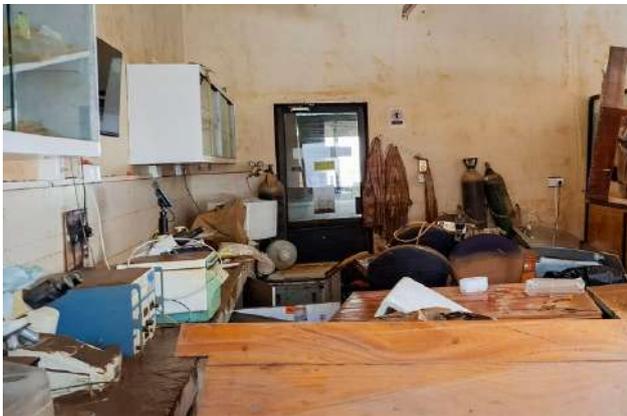
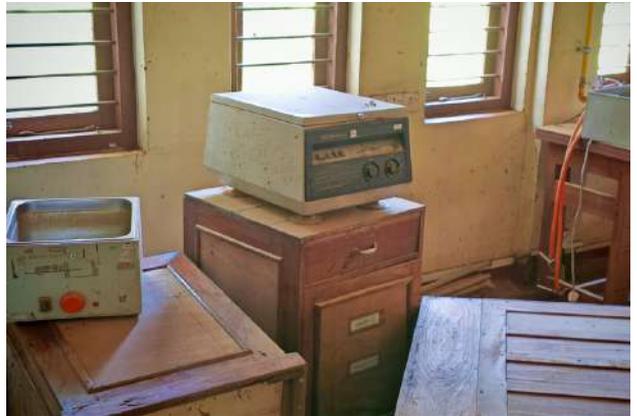
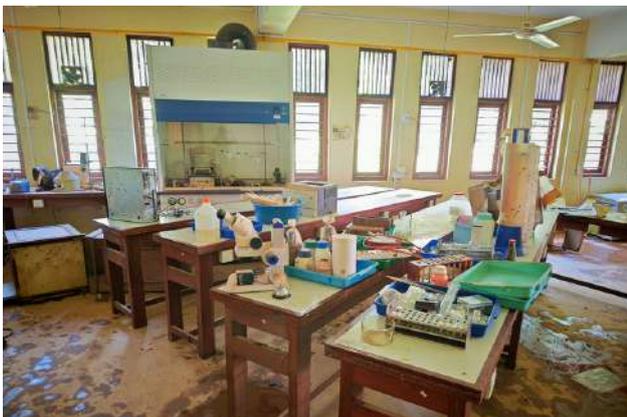
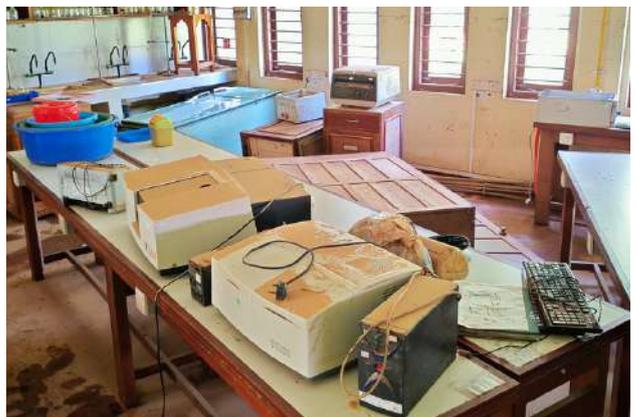
Figure 6. Flood damage to the Farm Animal Hospital and the Biochemistry Laboratory, the Faculty of Veterinary Medicine and Animal Science

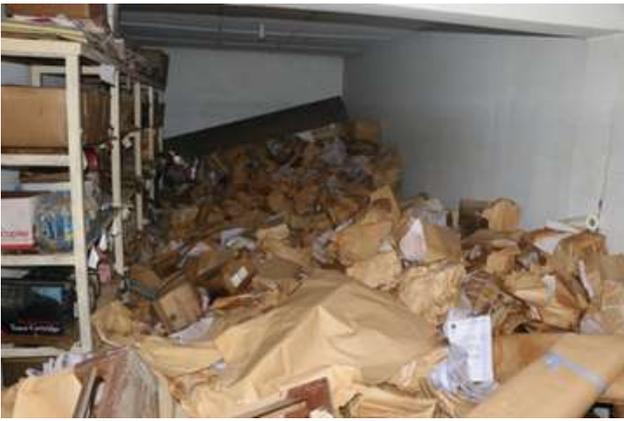
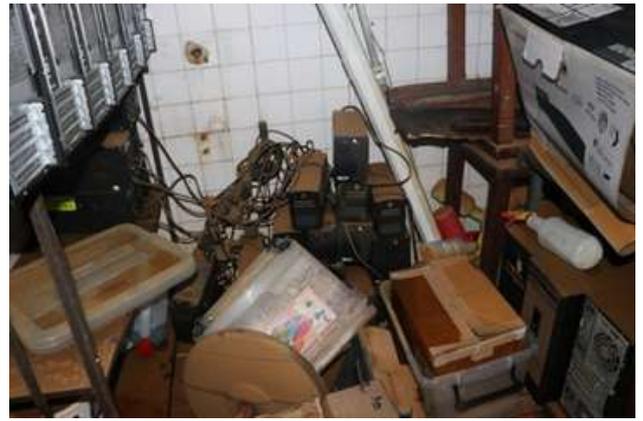
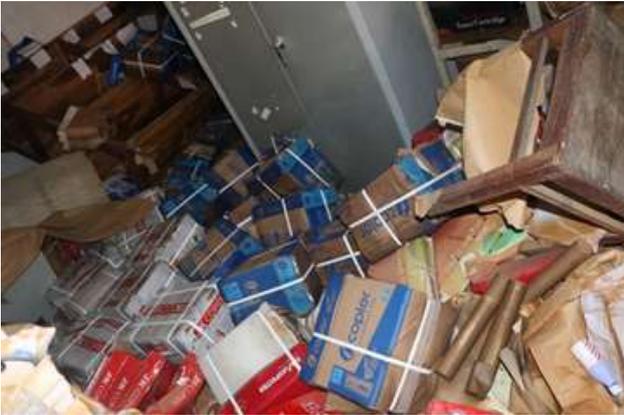
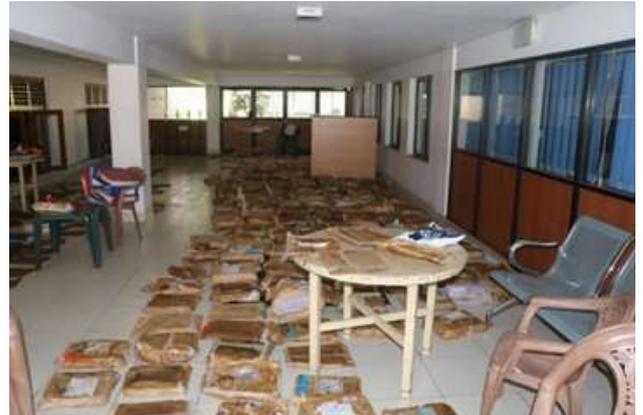
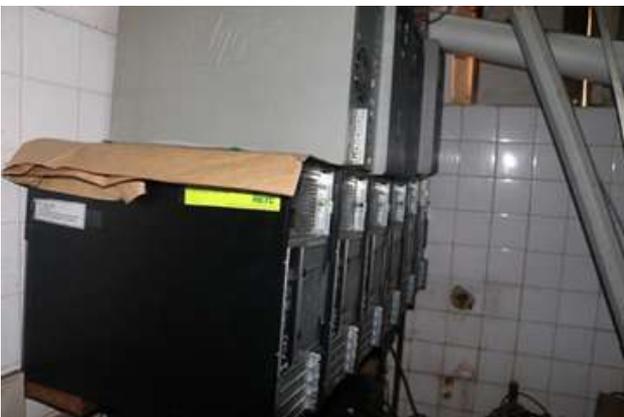
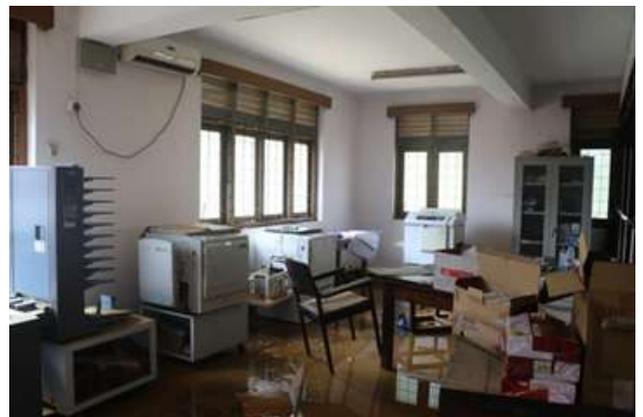
Figure 7. Flood damage to the Centre for Distance and Continuing Education (CDCE) at University of Peradeniya

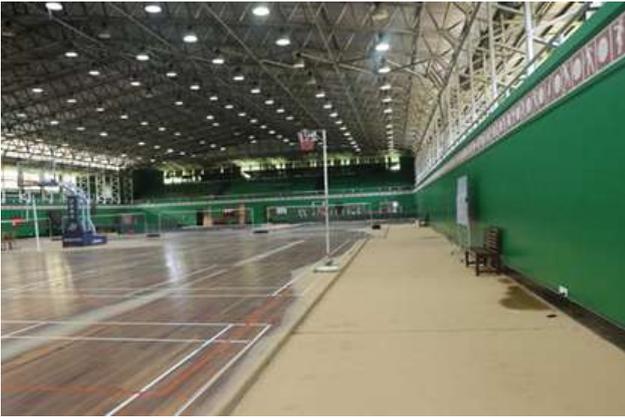
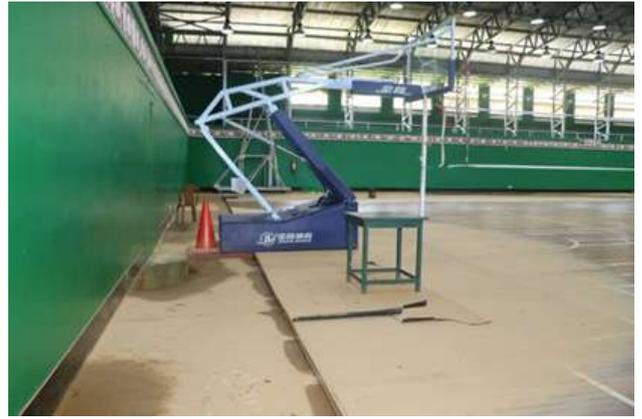
Figure 8: Flood damage to the University of Peradeniya Gymnasium

- Level of Damage: Partial
- Description of Damage: Weight training area is partially damaged.
- Recovery Action: Servicing and restoration.
- **Recovery Cost: Rs. mn 1.5**

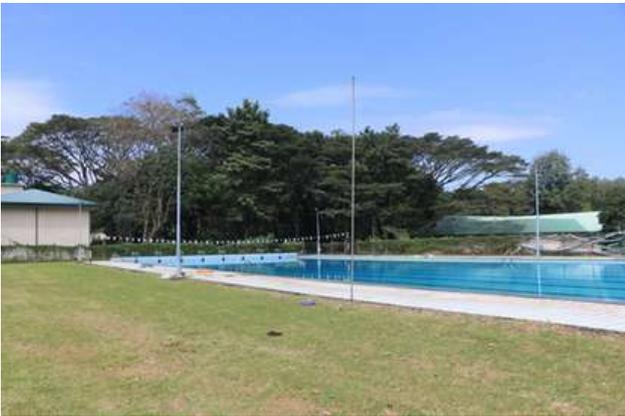
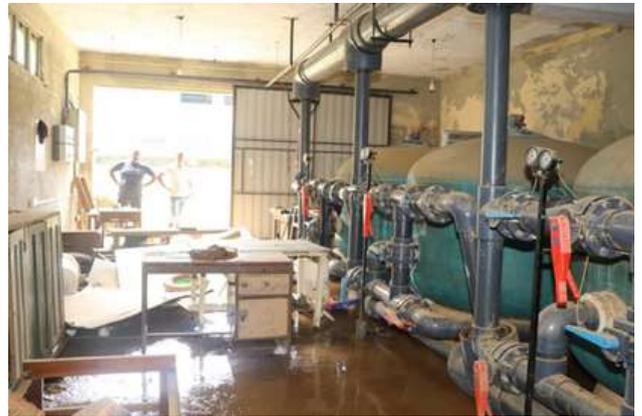
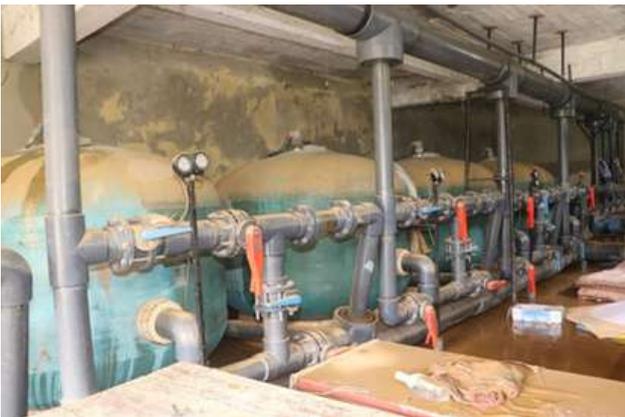
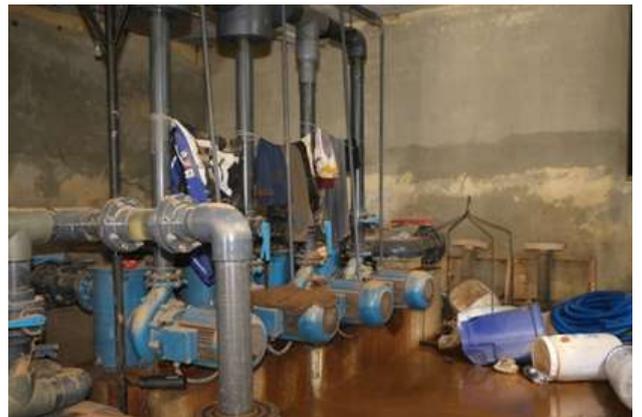
Figure 9. Flood damage to the University Pool

- Level of Damage: Partial
- Description of Damage: Damage to the swimming pool structure, retaining wall, and 4 pool pumps.
- Recovery Action: Restoration of retaining wall; repair of pool pumps (servicing, drying, and replacement of electronic components/panel boards). Potential full replacement and new retaining wall erection.
- **Recovery Cost (Rs. mn): Servicing and drying/electronic components (1), panel boards (1), Replacement (10), New retaining wall/compaction (15)**

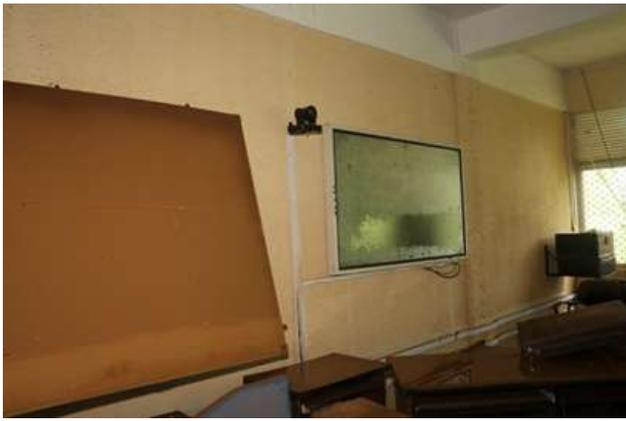
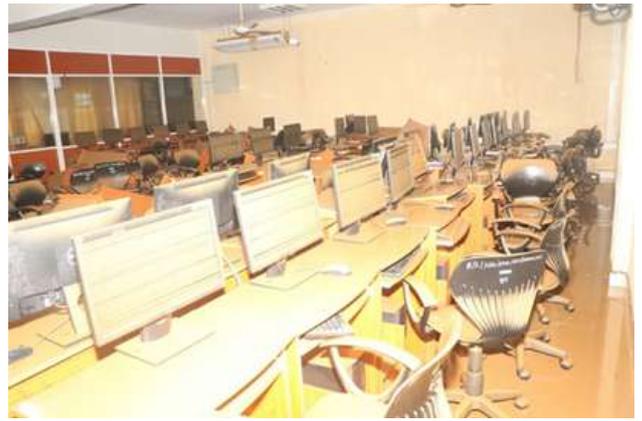
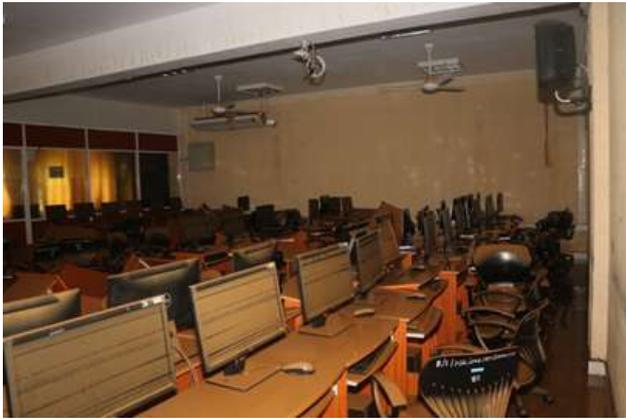
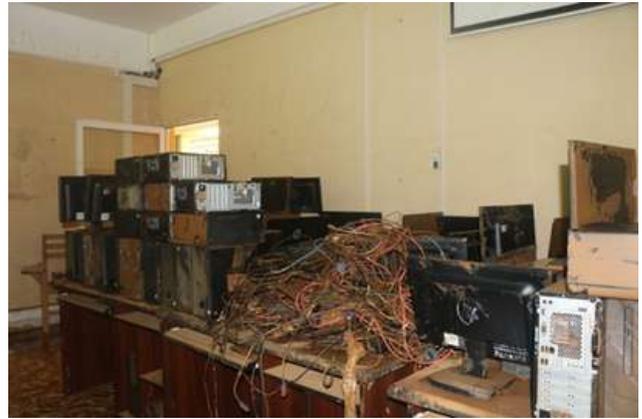
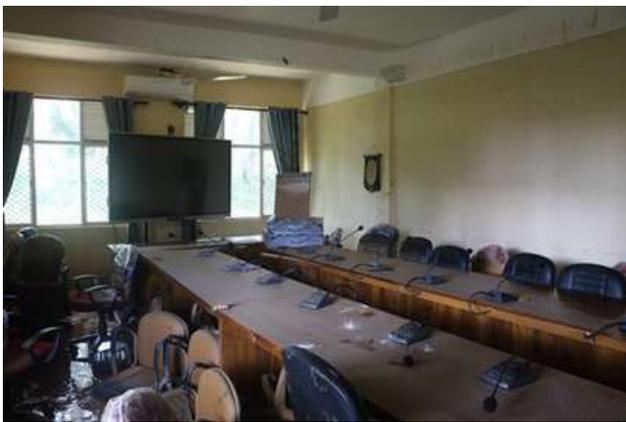
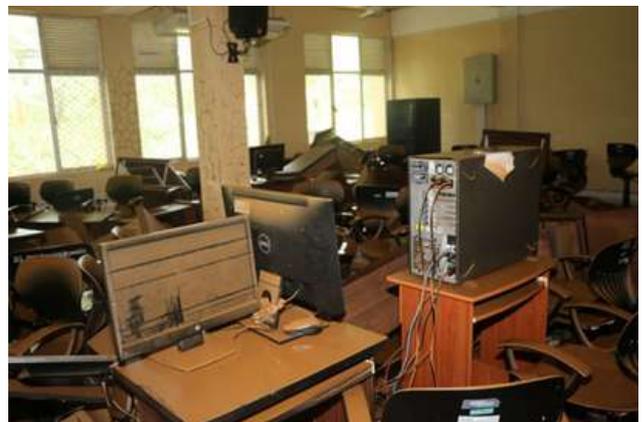
Figure 10. Flood damage to the Faculty of Management, University of Peradeniya

- Description: Complete electrical rewiring; replacement of distribution boards and circuit breakers; installation of new sockets and switches; restoration of main and sub power panels; full electrical safety testing; installation of lighting fixtures and establishment of the auditorium lighting system.
- Location: Entire Faculty Premises
- **Estimated Cost: Rs. mn 5 on**

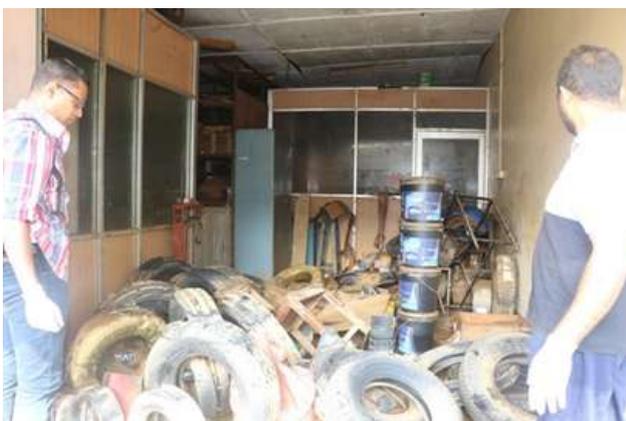
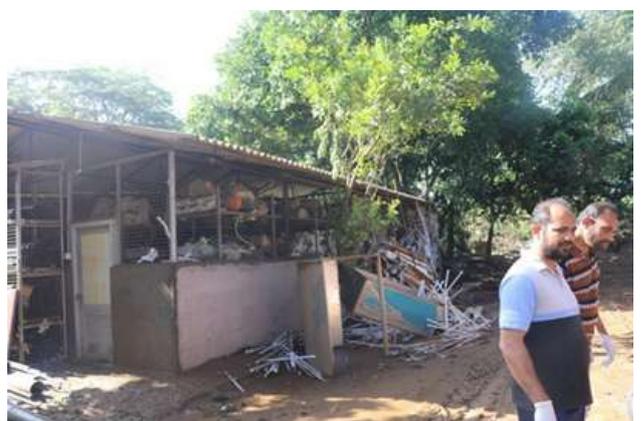
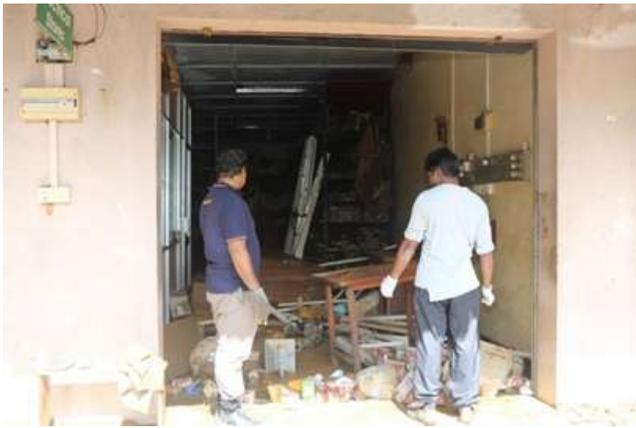
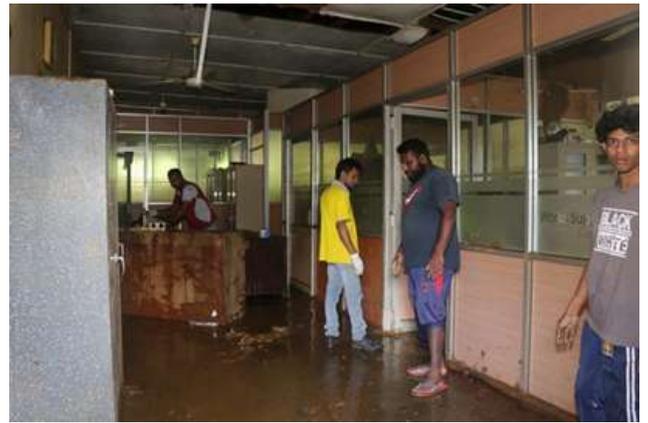
Figure 11. Flood damage to the Works Department, University of Peradeniya

- Level of Damage: Partial
- Description of Damage: Buildings completely flooded, with damage to the wall, roof, ceiling, retaining walls, structures, boundary fences, electronic items, tools, and office furniture.
- Recovery Action: Relocate and newly construct Works Department buildings.
- **Recovery Cost (Rs. mn): New construction to relocate (200), Replacing electronic and other tools/equipment (10), Furniture (4)**

- Level of Damage: Partial
- Description of Damage: Electrical Items (Bulbs, Panel Boards), Hardware (Cement, Paints, Thinner), Water Tanks, Computers, Laptops, and Photocopiers.
- Recovery Action: Replace.
- **Recovery Cost (Rs. mn): Replace (30), Relocation of stores building (40)**
